4 Cults Drive,  
Tomintoul,  
Ballindalloch,  
AB37 9HW

# Home Report

# Single Survey

<b>Property Address</b>	4 Cults Drive, Tomintoul, Ballindalloch, AB37 9HW
<b>Reference</b>	1159426
<b>Customer Name</b>	Charlotte Rogers
<b>Date of Inspection</b>	25th July 2025
<b>Surveyor's name, qualifications and office</b>	Calum Riach MRICS  DM Hall LLP Chartered Surveyors Hope House, Cradlehall Business Park, Castlehill Drive Cradlehall Inverness IV2 5GH  Tel: 01463 241077  email: invernessresidential@dmhall.co.uk
<b>Prepared By</b>	DM Hall LLP

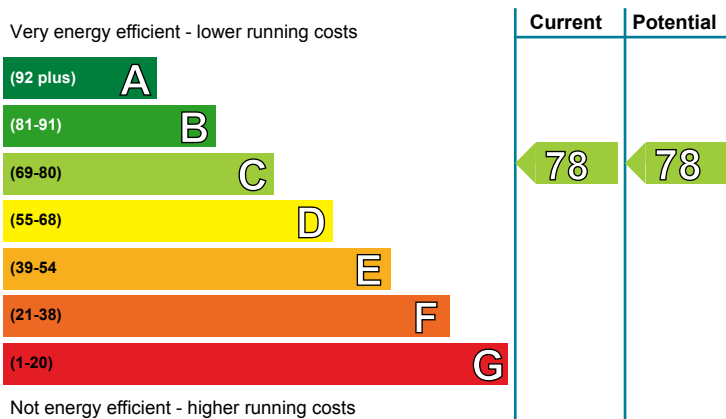
## Energy Efficiency Rating

This graph shows the current efficiency of your home, taking into account both energy efficiency and fuel costs. The higher this rating, the lower your fuel bills are likely to be.

Your current rating is **band C (78)**. The average rating for EPCs in Scotland is **band D (61)**.

The potential rating shows the effect of undertaking all of the improvement measures listed within your recommendations report.

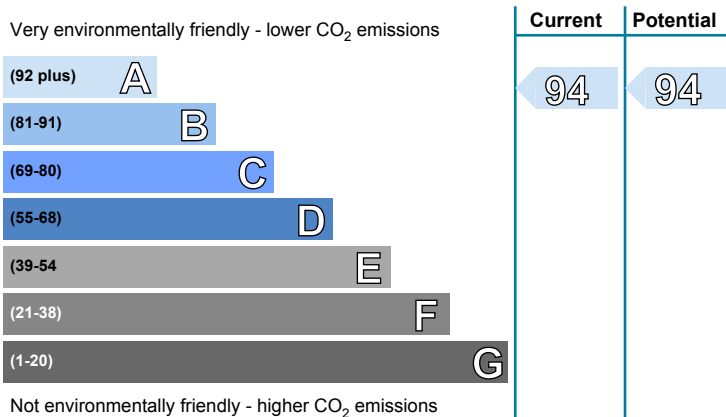
## Environmental Impact (CO<sub>2</sub>) Rating

This graph shows the effect of your home on the environment in terms of carbon dioxide (CO<sub>2</sub>) emissions. The higher the rating, the less impact it has on the environment.
